## **Preventing Ice Dams**

## Safeguard your home from a costly claim before the first snow fall

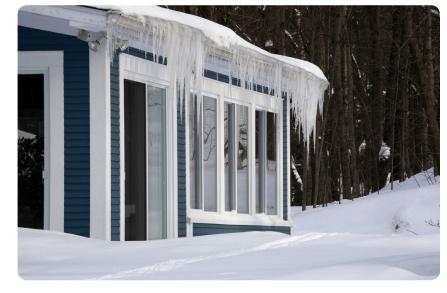
An ice dam is a wall of ice, sometimes a row of icicles, which forms on the edge of your roof where the gutters and edges meet. Ice dams are most often formed due to poor attic insulation and improper attic and roof ventilation. A poorly insulated attic results in a significant amount of heat leaving your home through the roof. The build-up of heat causes snow to melt at a faster rate. As fresh snow continues to accumulate, the melted snow can become trapped under the new, heavier snow. This buildup of water has nowhere to go and can ultimately seep into your home, damaging ceilings and walls.

There are several steps you can take to avoid ice dams:

- Clean your gutters and downspouts of debris so water can flow freely and away from the property
- Check for air leaks in the attic and seal where necessary
- Install proper insulation in your attic to mitigate heat loss
